# **CDF** Spotlight

The pleas of constituents to presidential aspirants

# 1.0 Introduction

# 3.0 NTA Research Methodology

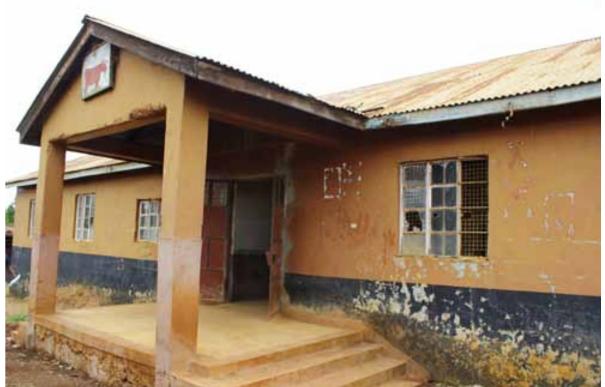
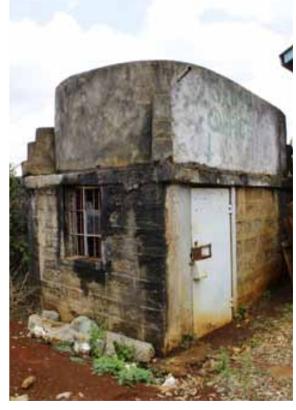
# **Gatundu South Dairy**

This project has taken too long to complete having received its first allocation in the 2006/07 financial year. Where construction works have been undertaken, relatively good quality materials were used but the majority of renovation works remain undone. With this allocation, a lot more could have been undertaken. The dairy is not yet operational and dairy farmers in the area have expressed their disappointment in this project.

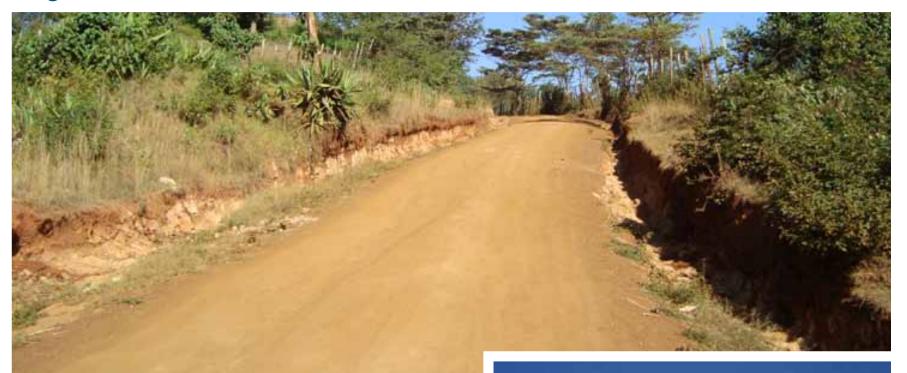
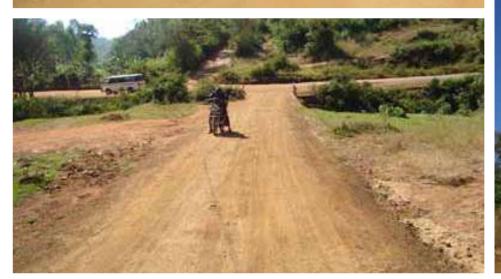
# **Magomano - Ituru Road**

Although certified complete, the grading of the road surface is not well done and the drainage system has not been well attended to. The drainage system is crucial to the life of any road and should be prioritized. The funds allocated to this project were enough to achieve alot more than what is on the ground.

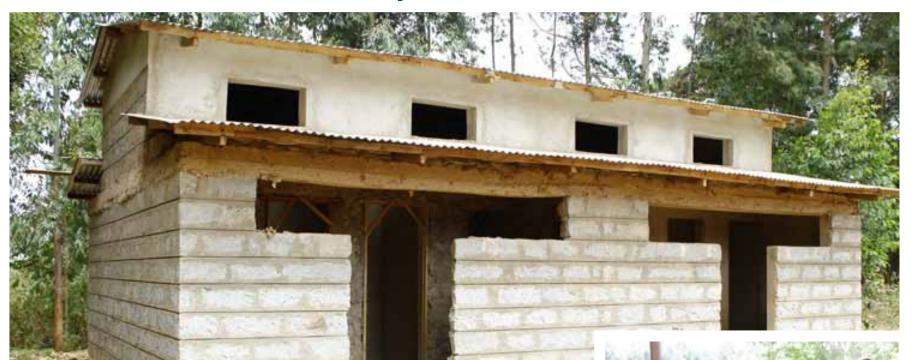
# **St. Peter's Karumandi South Primary School**

Project implementation commenced in 2009 but remains incomplete to date. Although good quality materials were used, major cracks have emerged on the walls depicting poor workmanship. The toilets that the pupils are currently using are in a deplorable state and are posing a health hazard. Additional funds need to be availed to revive this all important project.

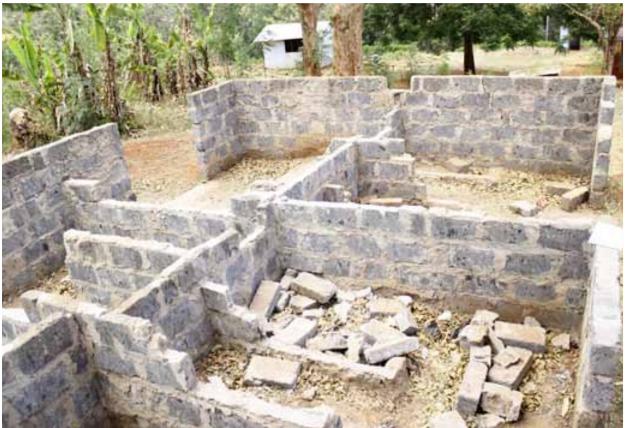
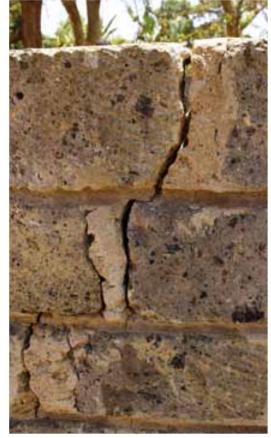
# **Raimu Primary School**

Although initially well implemented, construction works on this project have stalled owing to lack of adequate funding. Wear and tear due has naturally set in meaning the final cost on completion will be much higher than would have been the case had this project been implemented in good time. Additional funds need to be availed to complete this project.

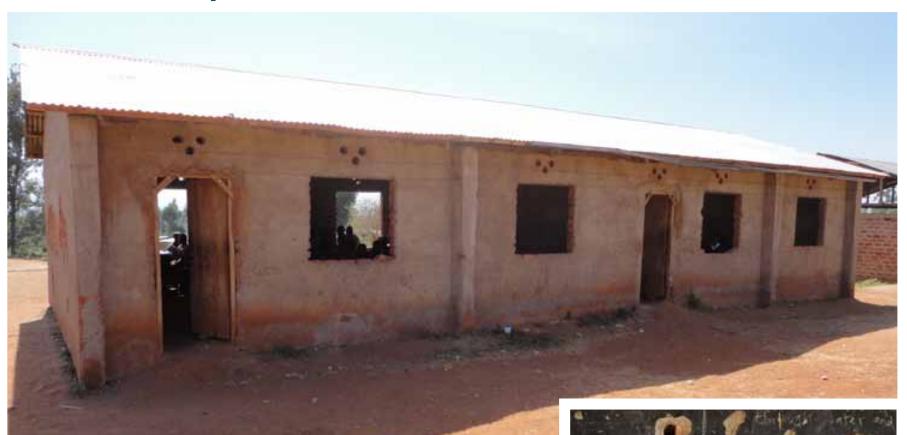
# **Chebukaka Primary**

Although the little resources were stretched to do substantive work, the quality of work is poor. Poor quality of bricks and wood instead of timber was used for roof trusses. Parents contributed windows worth 11,000.

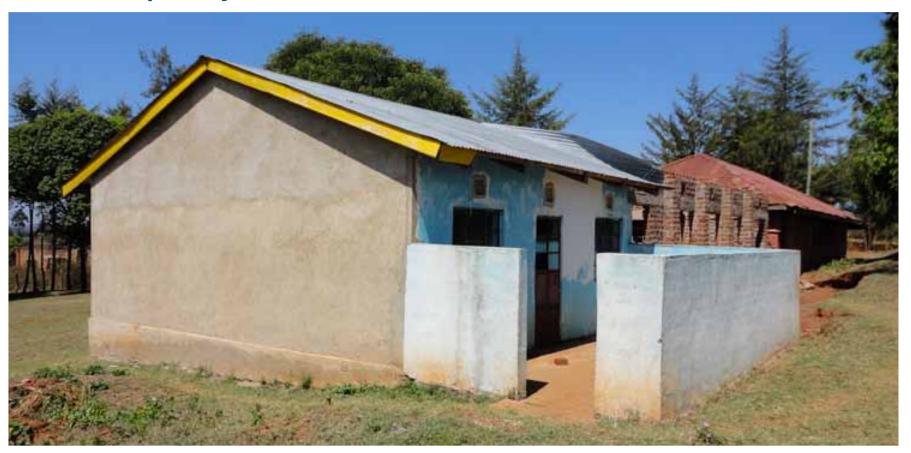
# **Kitaalale Dispensary**

The little available funds were stretched to do a lot of work but of poor quality. Cracks on the walls and floors. The project management committee did not consult the District public works officer before constructing the project thus poor implementation of the project.

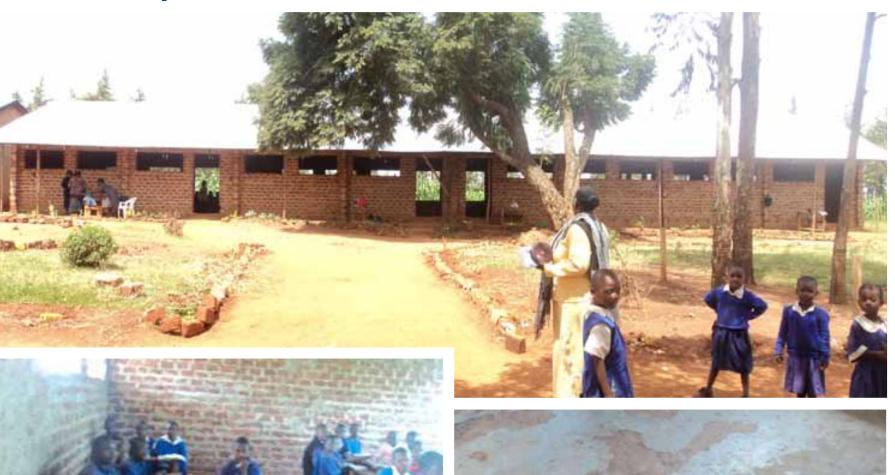
# **Sirende Primary School**

The project was poorly implemented, there are cracks on the floor and walls. Parents Teachers Association contributed Kshs. 328,900 and 112,100 bricks, Khetia's supermarket also contributed Kshs. 9,000 towards the project. The funds were not wisely used, the funds would have completed the project. The project represents no commensurate value for taxpayers money.

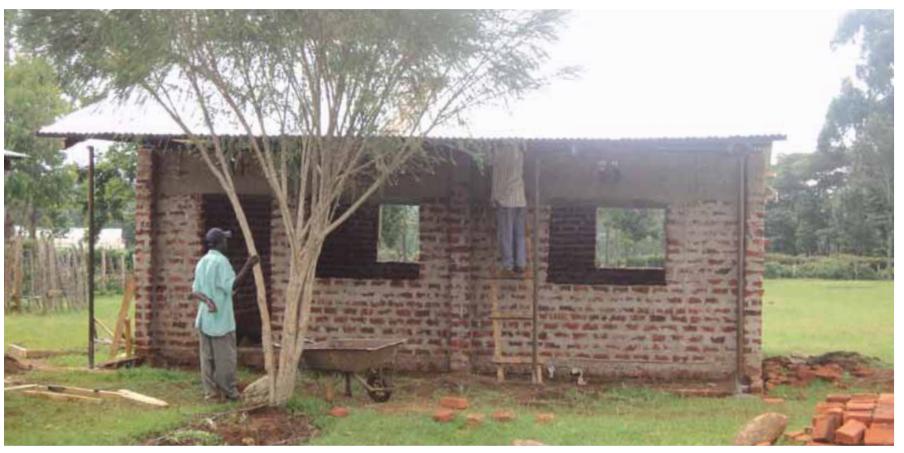
# **Mokoywet Primary School**

Poor workmanship is displayed in this project, the beams are not straight and roofing was poorly done. The project is taking long to be completed and the community is not happy with the slow pace of implementation. The Project management committee should speed up the completion of the project.

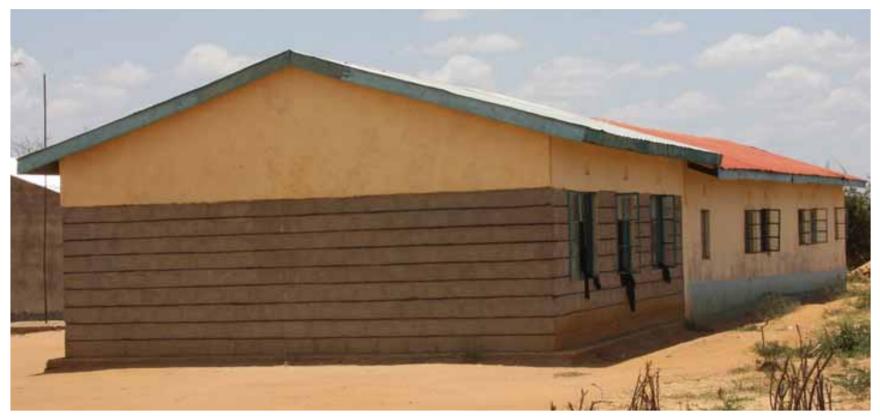
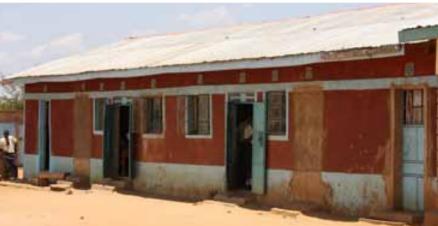
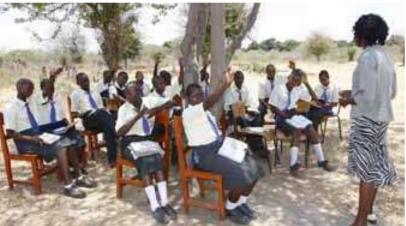
# **Mutwang'ombe Polytechnic**

The old building in the secondary school compound was constructed by the community in the 1980s. It was used as a polytechnic by then, but it was later changed to a secondary school in 2008. Despite there being no polytechnic, Mwingi North CDF allocated funds to the project for a period of three consecutive years as follows; in the financial year 2006/07, Cshs. 600,000 was allocated to the project followed by Kshs. 2000, 000 in 2007/2008 and in 2008/2009 Kshs. 250,000 was allocated to nonexistent project and the funds cannot be accounted for by the then project management committee. Information from the ground indicate that part of the CDF allocation was used to paint one side of the building with red paint before the polytechnic was converted into a secondary school but NTA was not able to get any document to show how the funds were used.

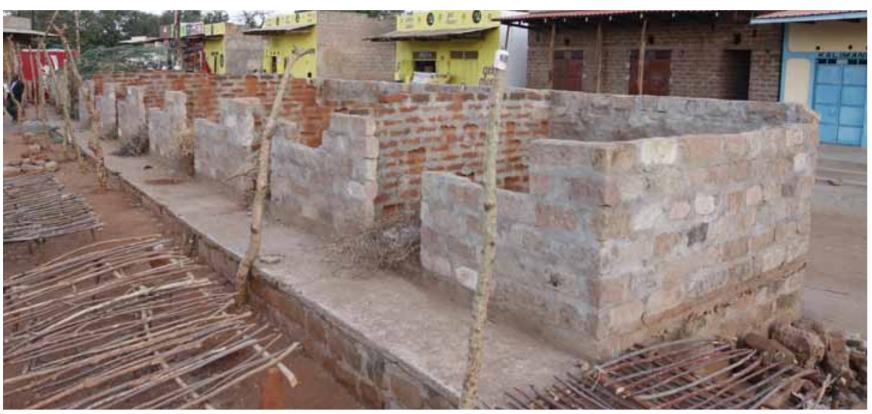
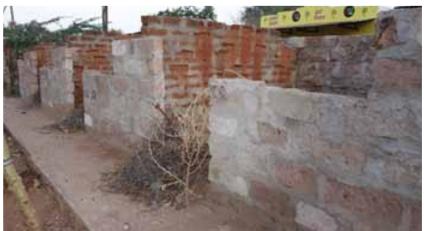
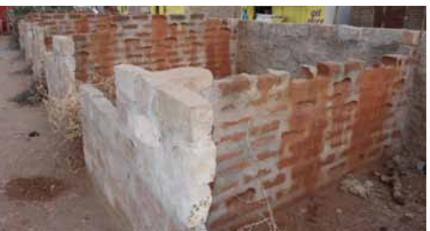
# **Tseikuru Market Shed**

The CDF allocation was meant to construct market sheds, but the project management committee instead started the construction of market stalls. Market sheds were meant to serve many market operators as opposed to the five abandoned stalls which would serve only few persons. This was against the market community proposal to Mwingi North CDF. The structure was abandoned at the wall level for the last three years. The market stalls have been poorly constructed with outside walls done using stones while the partition walls done using bricks. It is also important to note that a market shed is scheduled for construction in the same market under economic stimulus programme. This will lead to waste of resources and duplication of efforts.

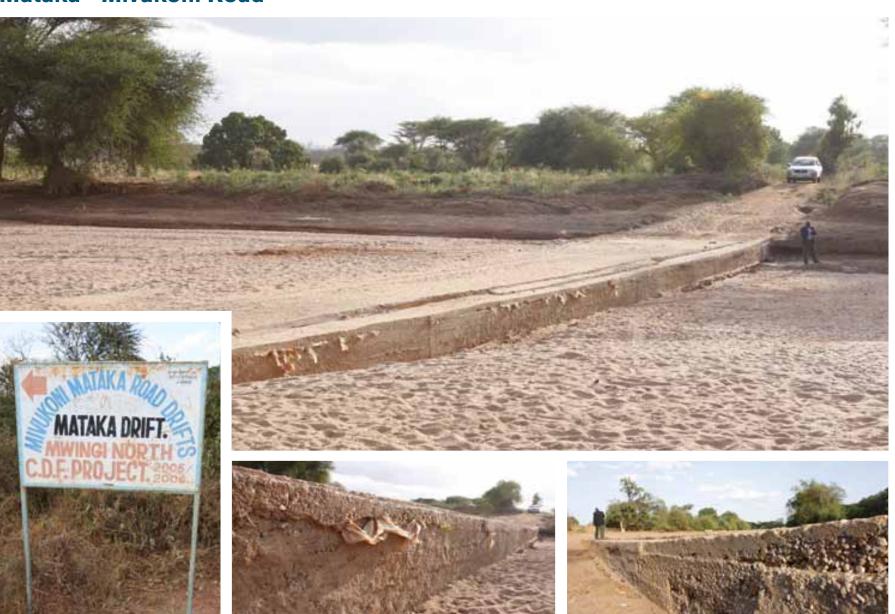
# Mataka - Mivukoni Road

The materials used to construct the drift were sourced locally. The structure is small in size and no reinforcement was used. The amount spent on the project is more than the work done and does not represent value for taxpayers' money.

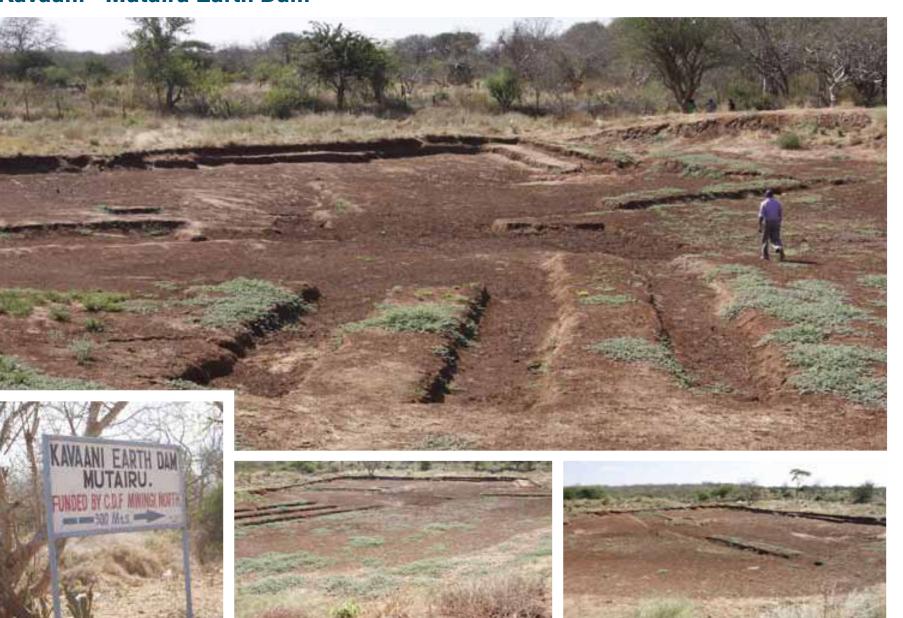
# Kavaani - Mutairu Earth Dam

The soil on the embankment was poorly compacted and the depth excavated is too shallow to store water in the reservoir. The spillway is so low that unnecessarily big freeboard was left.
The fencing was poorly done. The project's workmanship is poor and the overall output does not represent value for taxpayers' money.

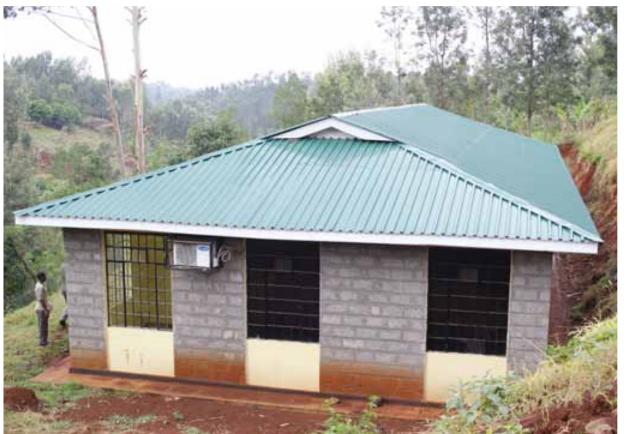
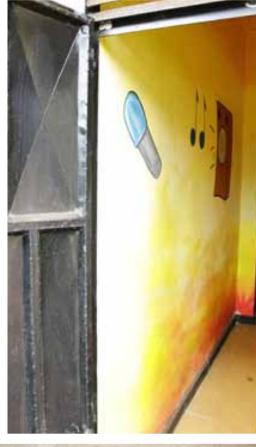
# **Gatanga Youth Empowerment Centre**

This is an impressive project. The empowerment centre boasts of a sound-proofed recording studio and hall/ theatre. The quality of workmanship is excellent and so are the fittings and finishes. The recording studio is also air conditioned and has a wall to wall carpet in addition to the recording equipment. The raised platform in the hall/ theatre is very well executed and so is the unique ceiling work. This project represents how taxpayers' funds should be used to develop communities and grow the talents of the young leaders of tomorrow.

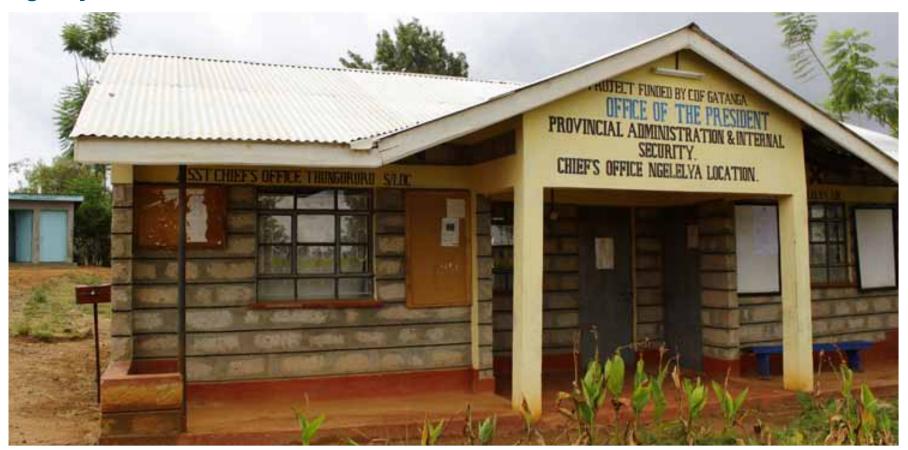
# **Ngelelya AP Post**

This project was well implemented, within good time and budget allocated. There is very high skill display in workmanship and very good choice of materials. Both structures are devoid of cracks and the finishes are well done. This project represents good value for taxpayers' funds.

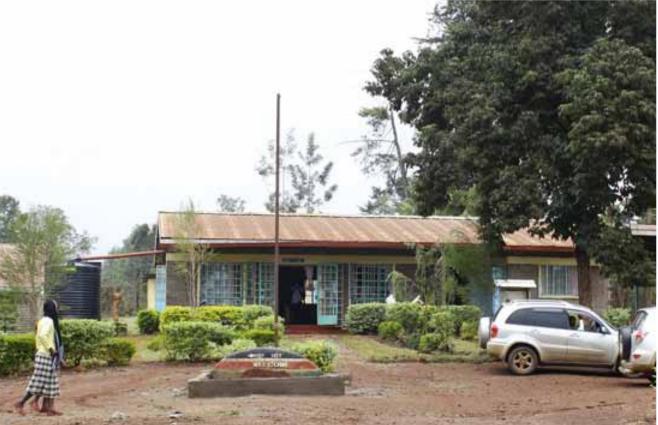
# **Kirwara Youth Polytechnic**

This project represents proper utilization of taxpayers' funds. The bulk of the funds were used for the purchase of computers, construction of 7 latrines, renovation works, purchase of tanks among other activities. The atmosphere within the computer room now makes for a very good learning environment for the students. These funds have been able to revive the polytechnic and its now of big benefit to the youth of Gatanga.

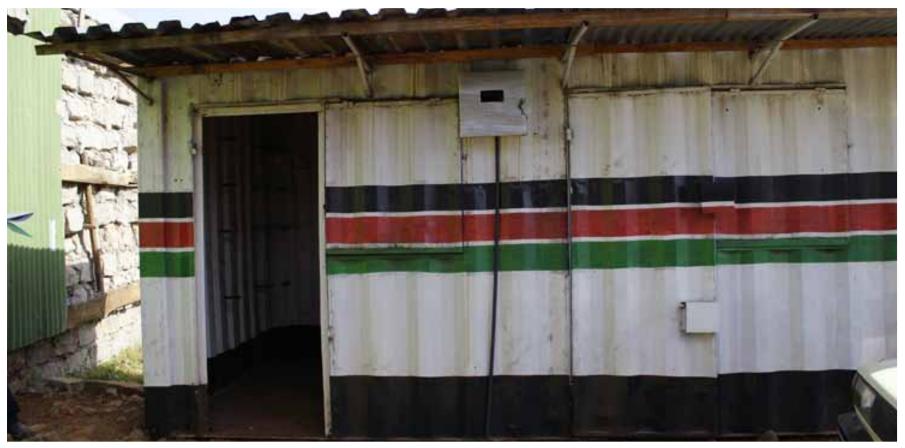
# **Langata Location Chief's Office**

This project was aimed at putting up a temporary structure for the chief, toilets, fence and parking bay Average quality of materials. Container is damaged at the back; murram could have been used as filling material. Poor finishing works. What has been implemented on the ground is not commensurate to the amounts spent. The toilet has caved in and the workmanship exhibited is poor. There is no value for taxpayer's money.

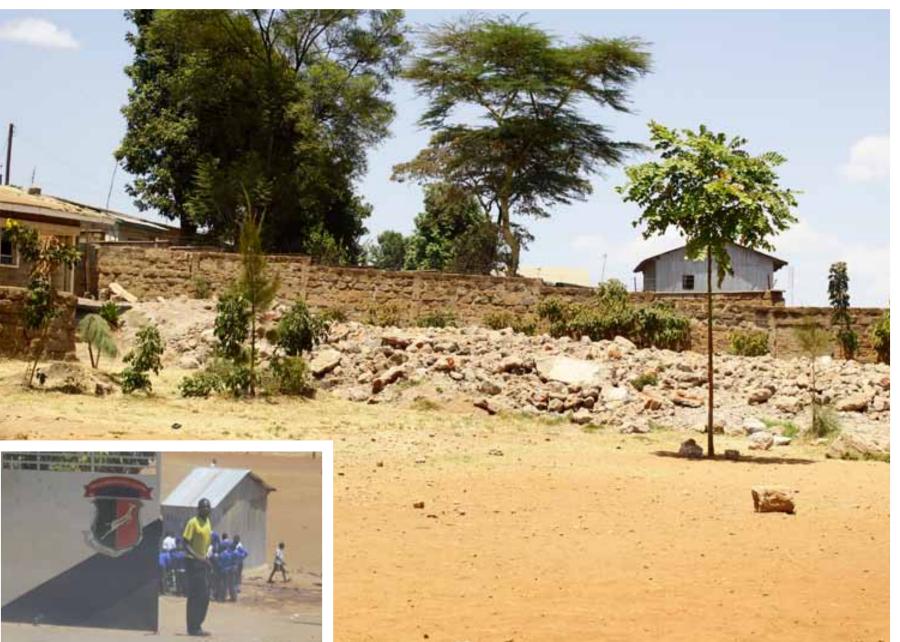
# **Raila Educational Centre**

The project was condemned and demolished as it was found to be a safety hazard to the occupants. This amount to a waste of taxpayers' money.NTA did not assess the project before the demolition.

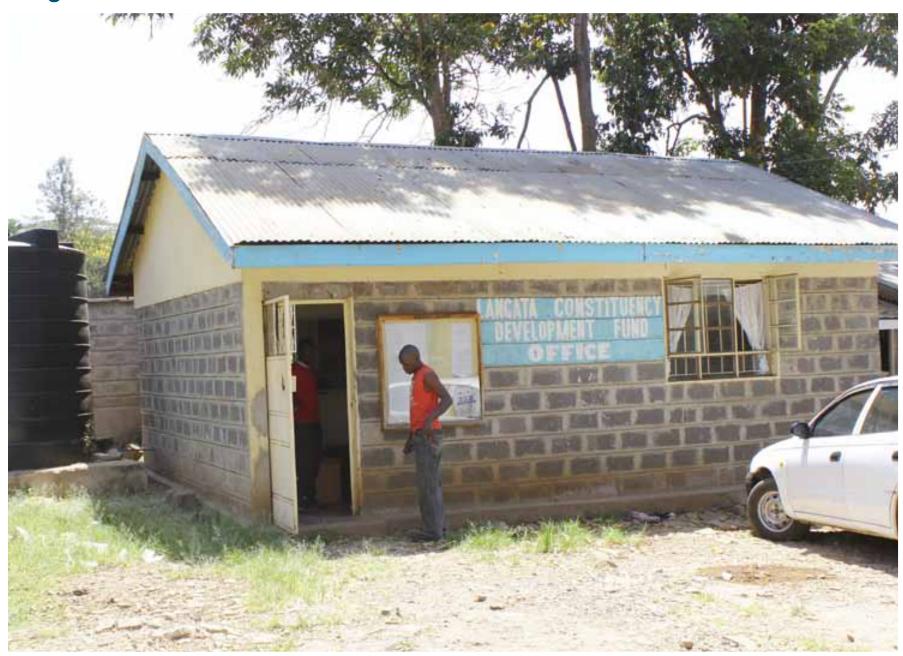
# **Langata CDF Office**

E- Ghost project.

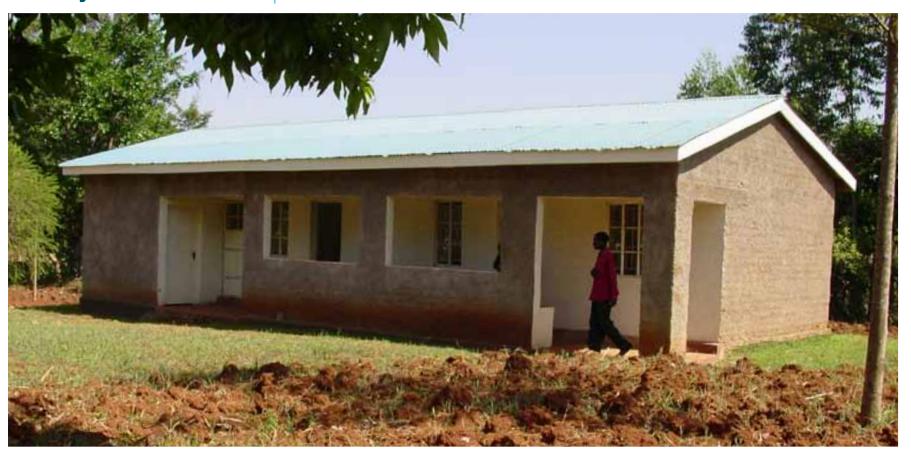
# Nadanya Health Centre | From 2004

Fairly good materials were used but poor workmanship as shown by cracks on the walls and the floor. The roofing was also done poorly. Amount spent compromised on quality and is lower than estimated project cost.
